UNITED STATES
NUCLEAR REGULATORY COMMISSION
OFFICE OF NUCLEAR MATERIAL SAFETY AND SAFEGUARDS
WASHINGTON, D.C. 20555

August 13, 2010

NRC INFORMATION NOTICE 2010-16: FAILURE TO DISABLE UNSAFE GEOMETRY
BANDSAW RESERVIOR RESULTS IN
CRITICALITY SAFETY-RELATED ALERT

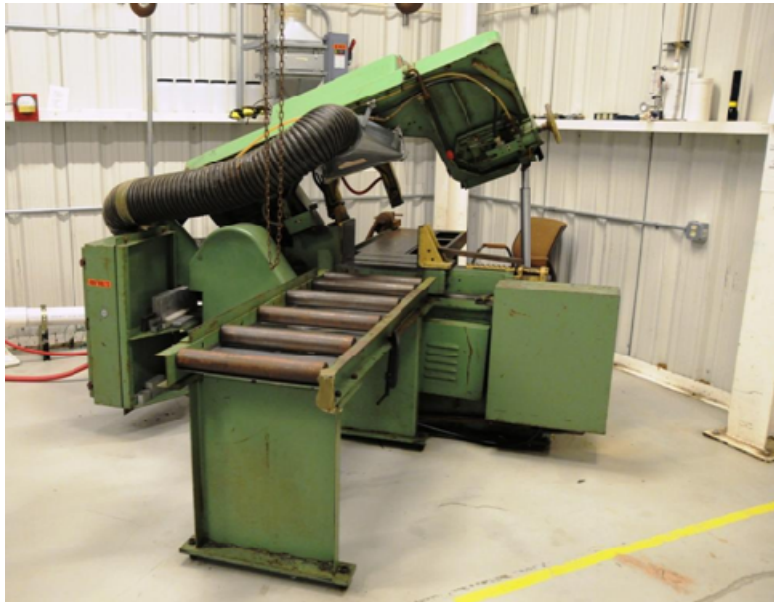
Figure 1
Band saw

B&W Nuclear Operations Group, Inc. (licensee) manufactures high-enriched uranium fuel, reactor core components and reactor cores for public and private sector customers at its Lynchburg, Virginia, facility. The licensee uses a large horizontal band saw, shown in **Figure 1**,

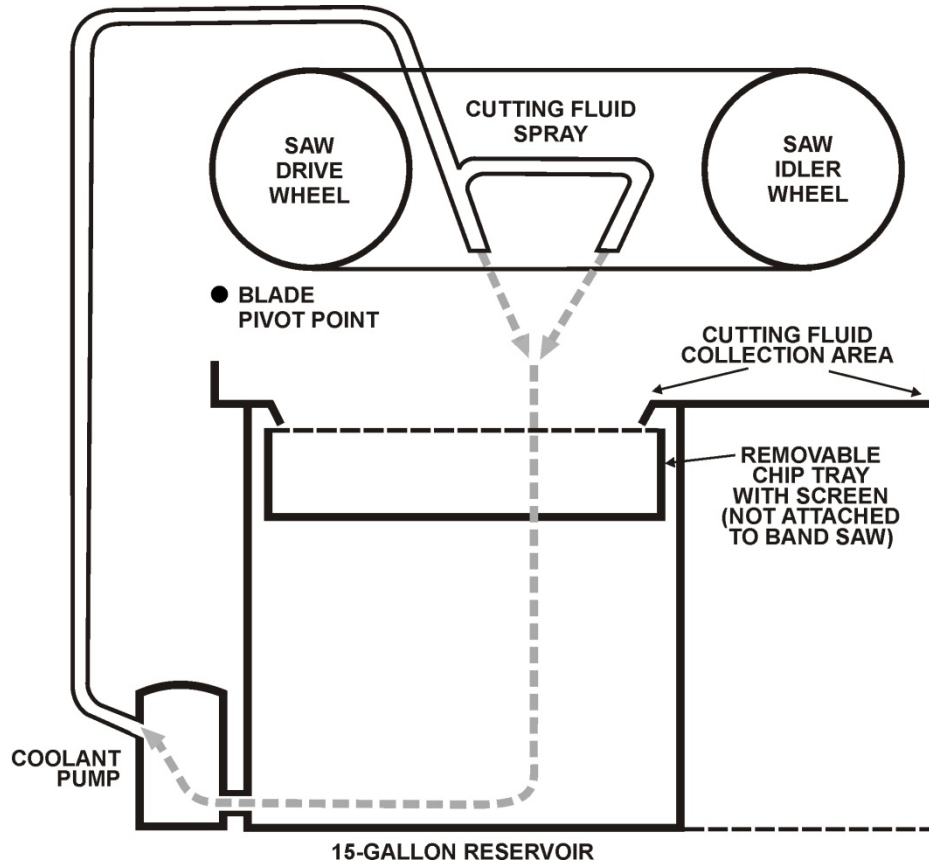
Figure 2
Original Band Saw Configuration

to cut fissile components during preparation of samples which may be requested by customers for destructive analysis. The licensee had performed cutting operations with the band saw for many years in its original configuration shown in **Figure 2**. In this original configuration, the band saw re-circulated cutting fluid through a 60 liter (15 gallon unsafe geometry) reservoir to lubricate and cool the saw blade and component during cutting operations.

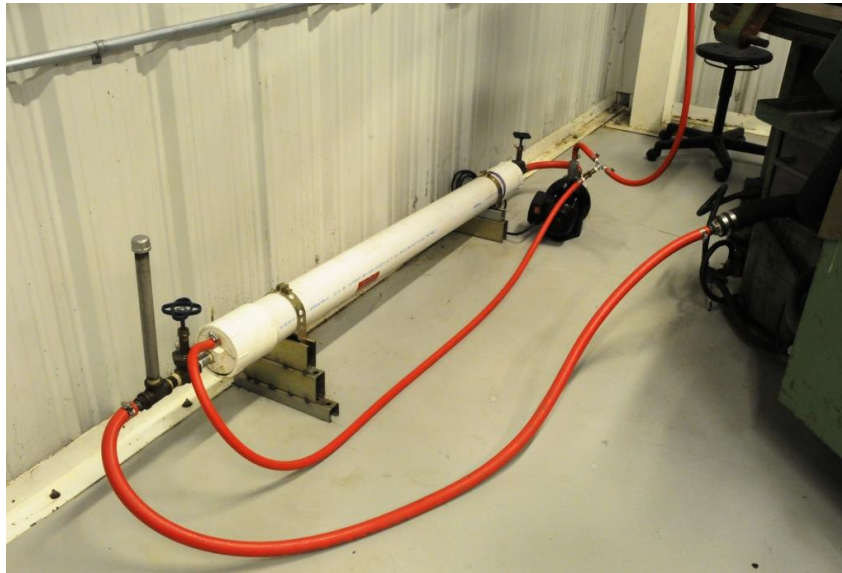
Figure 3
External Safe Geometry Column

In 2003, based on the need to prepare samples for evaluation, the licensee decided to move the band saw to its current location. Criticality safety analysis of the proposed relocation resulted in the requirement that the band saw cutting fluid system include favorable geometry components. This resulted in the installation of a new external cutting fluid reservoir as shown in **Figure 3**. To facilitate use of the new favorable geometry cutting fluid reservoir, a new chip tray was designed and substituted for the previous chip tray that had a screen on top of the old cutting fluid reservoir as shown in **Figures 4 thru 7** on the next page.

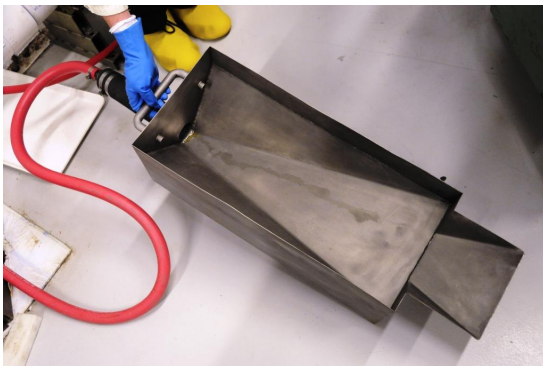
Figure 4
Modified Chip Tray

As shown in **Figure 4**, the previous chip tray with screen was replaced with a sloped tray which directed the cutting fluid out of the body of the band saw to the new external cutting fluid reservoir on the floor. The new chip tray did not have a screened bottom and fissile material chips were filtered out of the cutting fluid by a small round screen in front of the tube at the exit of the new chip tray. The modified band saw configuration is shown in **Figure 8**. During cutting

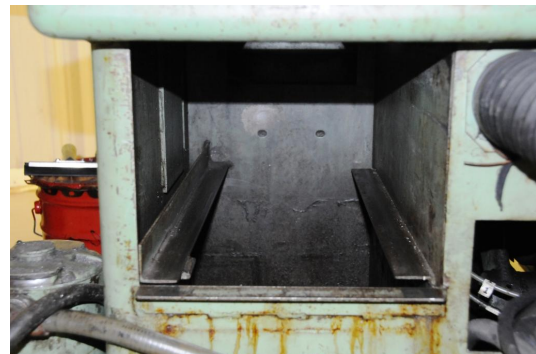
Figure 5
Chip Tray Location

As shown in **Figures 5 and 6**, the old cutting fluid reservoir could not easily be seen even with the new chip tray removed and the operators had no reason or motive to look during routine operations. The licensee always used the same two operators with the band saw and these operators were trained and experienced enough to know that solution in the old cutting fluid reservoir was an upset condition.

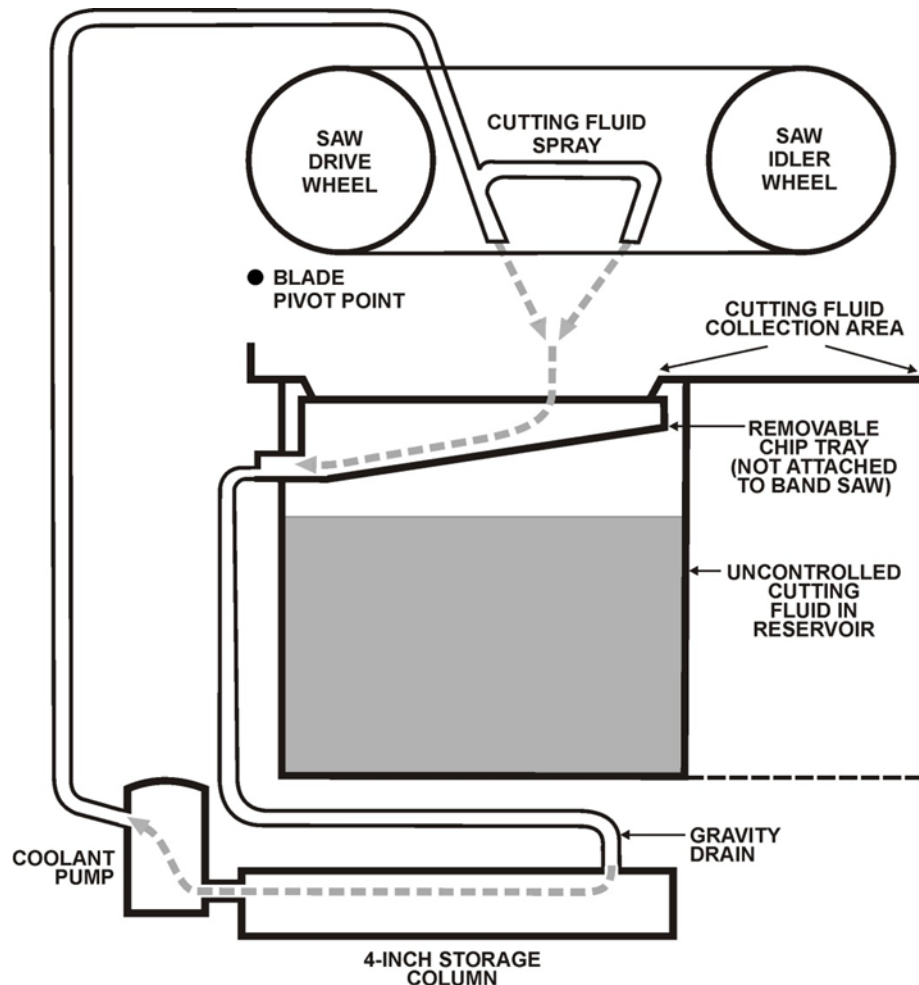
Figure 8
Modified Band Saw Configuration

operations with the modified band saw, the cutting fluid is pumped from the new external cutting fluid reservoir back to the spray nozzles, collected by the removable cutting fluid tray and drained back to the new external cutting fluid reservoir. Only a limited amount of cutting fluid remains in the new chip tray. When this modification was implemented, the licensee safety organization, using a procedure known as a criticality safety release, directed that the old cutting fluid reservoir, formed by the body of the band saw, be disabled. The nuclear safety release for the modified band saw specifically stated *"If each machine has a built in coolant [cutting fluid] reservoir it shall be disabled such that it is not usable."* No specific instructions were provided in the release for disabling the old cutting fluid reservoir on the band saw and no actions were taken by the licensee during installation to disable the old cutting fluid reservoir.
